BELZONA REBUILT HEAT EXCHANGER COVER

ID: 1283

Customer Location: *Ship Dockyard, Bulgaria*
Application Date: *June, 2008*

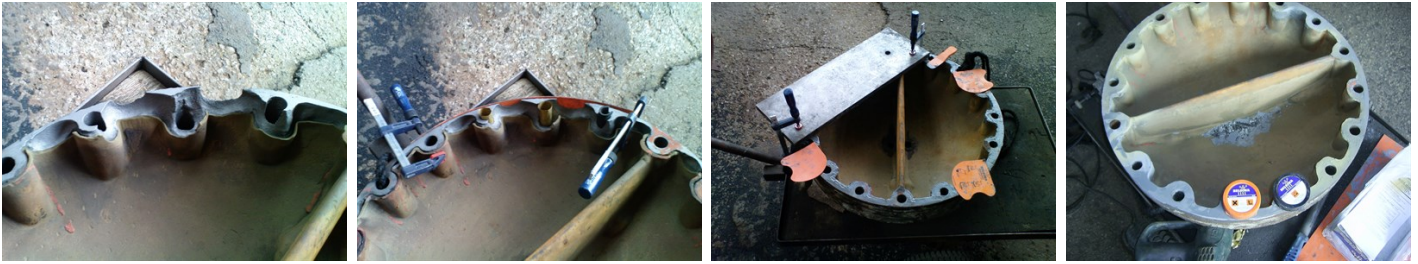
Damage on the original profile of the cooler top-cover due to erosion/corrosion, led to leaks and loss of efficiency.

- * Damage to top-cover clearly evident ,
- * Formers were used to restore profile ,
- * Repair of top-cover flange face in progress ,
- * Finished repair ,

Application was carried out in accordance with Belzona Know-How System Leaflet HEX-2. After blasting the damaged area and flange surfaces of the top-cover were restored by forming technique and Belzona® 1111.

Cost effective and quick method of rebuilding and contouring of the original cooler top-cover profile. Belzona repair fully restored the efficiency of heat exchanger. Significant cost saving to the customer as alternative was equipment replacement.
