# BELZONA PROVEN PROTECTION OF STEAM TURBINE

ID: 1290

Customer Location: Vladimirsky Power Plant/ Russia

Diaphragm and channels under the end journal of medium pressure steam turbine.

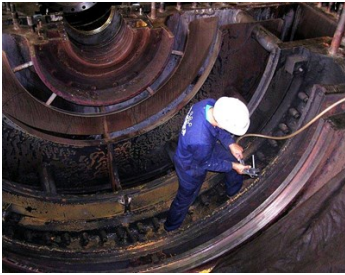
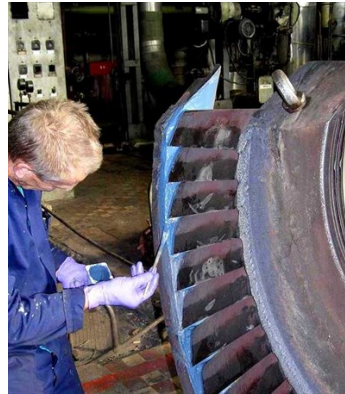
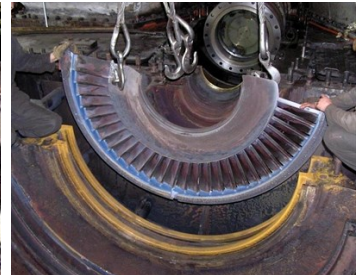
After more than 35 years (253.000 hours) in-service, inspection during shutdown in 2003, revealed that turbine faced severe stream erosion caused by humid steam. Damages were up to 8 mm wide and 10 mm deep.

\* Grit blasting underway , \* After blasting extent of damage clearly evident , \* Application of Belzona® 1391 , \* Completed job ,

Application was carried out in accordance with a modified version of Belzona Know-How System Leaflets CEP-3 & -5.

After 5 years in-service turbine has been inspected (July 2008) and results were very satisfactory. Channel around the nozzle blades had been preserved 95-100%. Also Belzona® 1391 on the rebuilt areas was practically undamaged. In a zone of phase transition, minor damages were easily repaired.
