BELZONA REBUILDS TURBO SEPARATOR

ID: 1291

Application: *SHM-Solids Handling Machinery*

Customer Location: *Pulp & Paper Plant, Bulgaria*

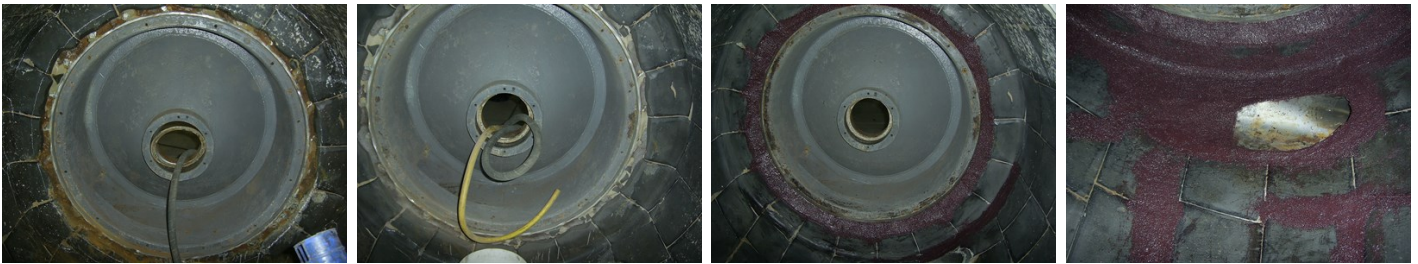
Photograph Descriptions

The basalt tile lining suffered severe abrasion during pulp separation and as a result a lot of broken edges and cracked tiles were present.

- * View of the damaged tiles around turbo separator outlet ,
- * The same view of the outlet after grit blasting ,
- * Belzona® 1811 applied to restore damaged tiles ,
- * Close up view of the repaired separator inlet ,

Application was carried out in accordance with Belzona Know-How System Leaflet SHM-7. Belzona® 1811 was applied to restore surface profile and to produce as smooth as possible surface.

Replacing the broken and cracked tiles was not an option due to cost and time constraints. Belzona was chosen for its fast and in-expensive application. whole repair was done within 48-hour period thus restoring an even surface profile with similar abrasion resistance compared to basalt.
