BELZONA PROTECTS ION-EXCHANGE FILTER

ID: 1295

Customer Location: Power Plant, Moscow, Russia
Application Date: November 2008

Interior coating of ion-exchange filter used to produce water for boilers

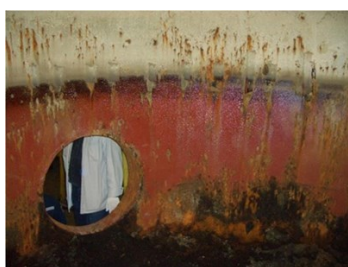
There were blisters, holes and layer of salts under the original polymeric coating after more than 50 years of service. When old coating was removed many corrosion pits in the substrate were detected.

Application was carried out in accordance with Belzona Know-How System leaflet TCC-5. Deep holes were welded. Small areas of corrosion pitting was rebuilt with Belzona 1111. Coating was applied by heated airless spray.
