# BELZONA SEALS HYDRAULIC LEAK

Application: VPF-Valves, Pipes and Fittings

Hydraulic system of press for stone products

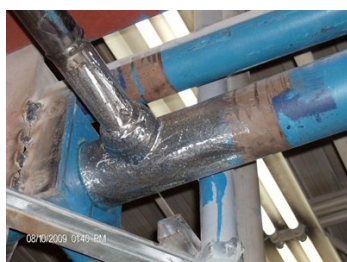
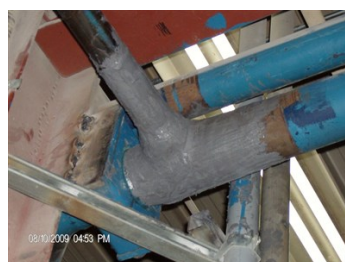
Hydraulic pipe had started to leak causing the fluid to drip onto the electrical circuit panel, causing a shutdown.

- \* Leaking weld joint ,
- \* Surface preparation ,
- \* Completed repair ,

Application was carried out in accordance with Belzona Know-How System Leaflet VPF-11a. A wrap using the Belzona® 1111 with Belzona® 9341 (Reinforcement Tape) was used to encapsulate the leaking weld.

Repair was able to stop the leak and get the operating press back up and running in a short amount of time minimizing disruption to production.
