# BELZONA REFURBISH BLAST FURNACE "BELL ROD" IN-SITU

ID: 130

Customer Location: Steel Mill in Mid West of U.S.A.  
Application Date: February 1995

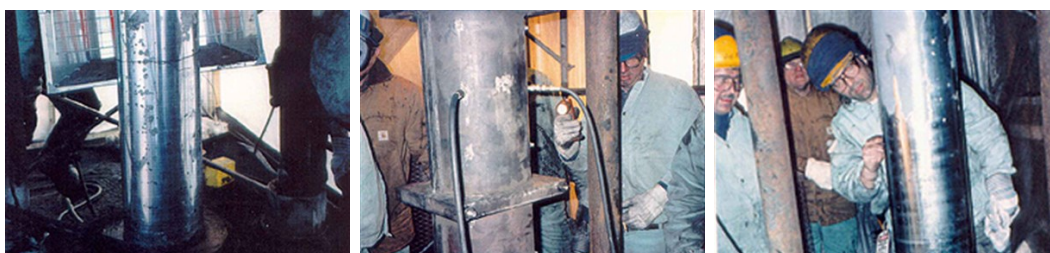
## Photograph Descriptions

Chrome plating on the rod had been damaged in places which had allowed corrosion to take place. The size and location of the part made preparation difficult and reduced the opportunity for dimensional finishing of the job after application.

- \* View of the damaged bell rod ,
- \* Belzona® 1321 being injected into the former ,
- \* The completed job with admiring crowd ,

'Bell Rod' on top of blast furnace, 60 metres above ground level

Application was carried out in accordance with a modified version of BelzonaKnow-How Leaflet MPT-2.
