BELZONA SAVES MONEY ON THE REPAIR OF A TRUNNION

ID: 133

Trunnion bearing

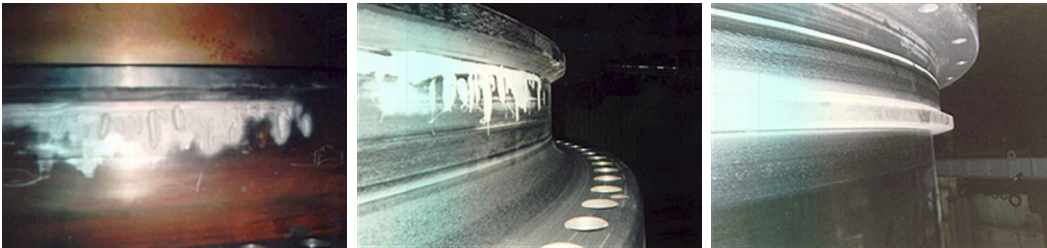
The seal area of a trunnion bearing had been badly scored by the ingress of foreign matter behind the seal.

- * Damaged seal area ,
- * View of trunnion bearing ,
- * Repair successfully completed ,

In accordance with Belzona Know-How Leaflet MPT-3.

The customer saved approximately \$150,000. Other repair methods had been tried and had failed. Using the Belzona eliminated the possibility of generating further stress cracks in the casting, removed the anxiety factor associated with welding and the worst case scenario - scrapping the unit.
