TRANSFORMER LEAK SEALED WITH BELZONA

ID: 1331

Customer Location: *Power Plant, Lithuania*
Application Date: *September 2009*

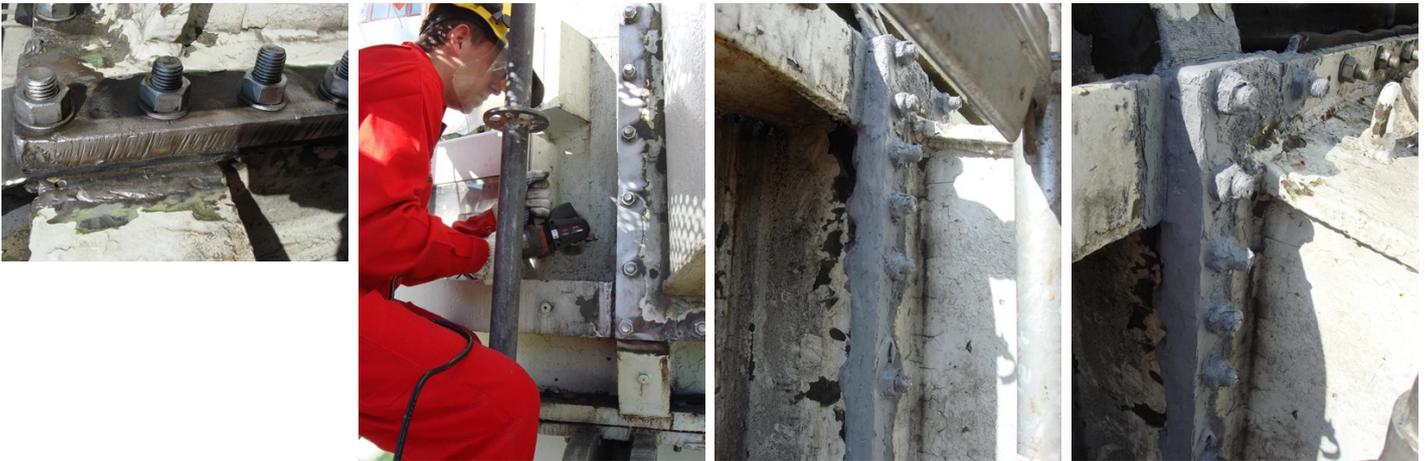
Photograph Descriptions

- * Paint and other contamination removed ,
- * Substrate roughened ,
- * Belzona® 1161 and Reinforcement Tape applied ,
- * Second layer of Belzona® 1161 ,

Transformer was leaking oil through the flanges.

Application was carried out in accordance with Belzona Know-How System Leaflet TCC-1.

Plant has tried other products but none of them gave satisfactory results. Belzona solution provided means of sealing the leaks without interruption to supplies.
