# TRANSFORMER LEAK SEALED WITH BELZONA

ID: 1331

Customer Location: Power Plant, Lithuania  
Application Date: September 2009

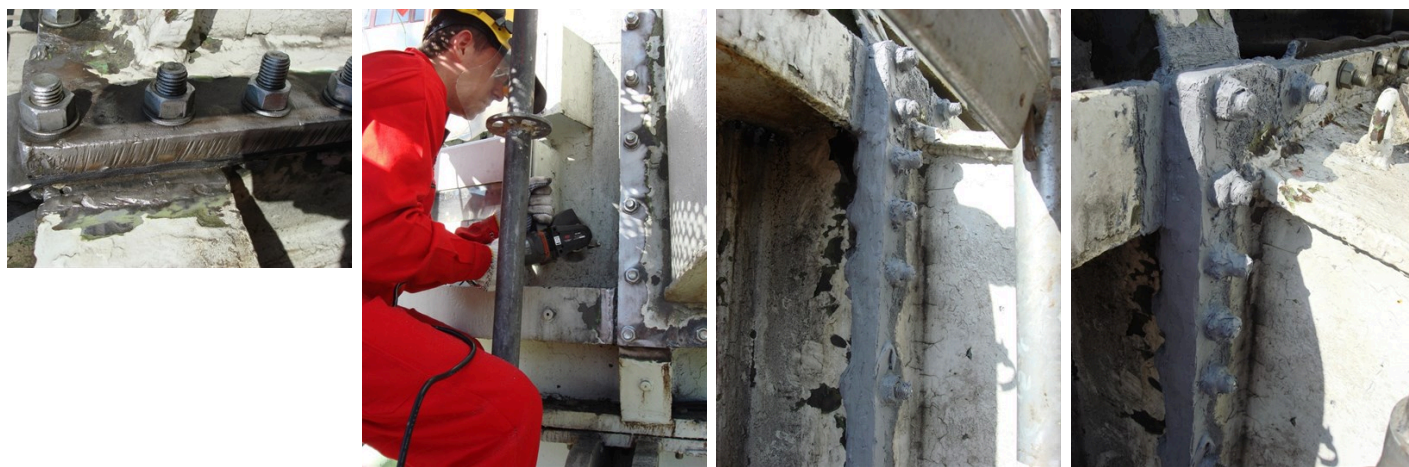
- \* Paint and other contamination removed ,
- \* Substrate roughened ,
- \* Belzona® 1161 and Reinforcement Tape applied ,
- \* Second layer of Belzona® 1161 ,

Transformer was leaking oil through the flanges.

Application was carried out in accordance with Belzona Know-How System Leaflet TCC-1.

Plant has tried other products but none of them gave satisfactory results. Belzona solution provided means of sealing the leaks without interruption to supplies.
