BELZONA KEEPS TIRE ROLLING

Industry: Mining & Quarrying
Application: SHM-Solids Handling Machinery

Problem

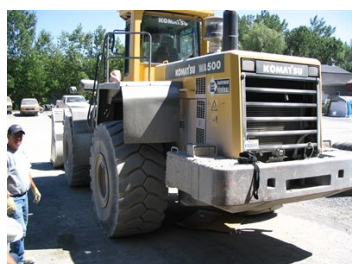
Damage on tire sidewall was exposing steel reinforcement to corrosion

* The equipment Crack was veed out and prepared with Belzona roughing brush Belzona® 9341 (reinforcement Tape) incorporated for additional strength The completed repair ,
