BELZONA REPAIRS AND PROTECTS 18 FOOT DIAMETER FLANGE FACE

ID: 1337

Customer Location: *Metallurgy, Montreal Canada*
Application Date: *October 2006*

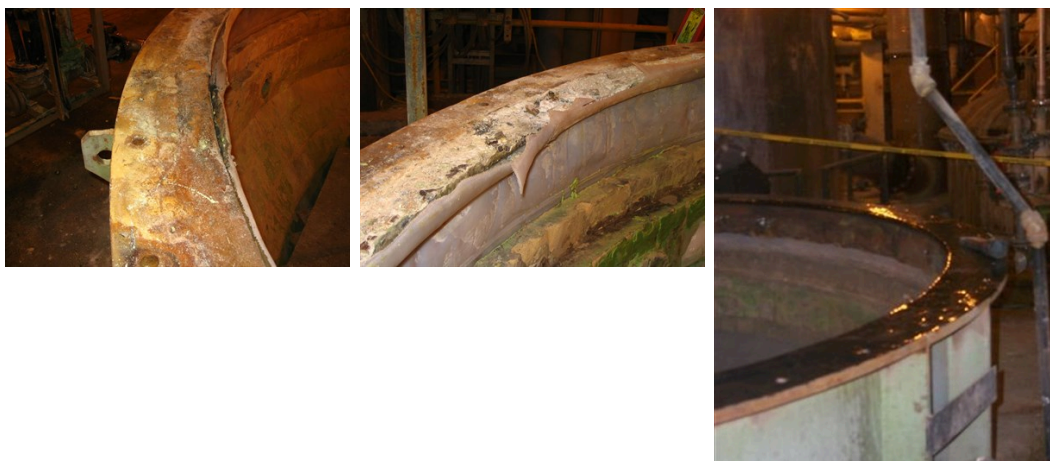
Photograph Descriptions

Flange was attacked by 98% Sulfuric acid at elevated temperature after Teflon lining was damaged.

- * Metal flange needed rebuilding. ,
- * The damaged Teflon lining that caused leak ,
- * The rebuilt flange protected with Belzona® 4341 ,
- * ,

Flange on 18ft. diameter evaporator.

Application carried out in accordance with Belzona Know-How System Leaflets GSS-8 and HEX-3. Templates were used to obtain original profile of the flange with Belzona® 1111. Belzona® 4341 was applied as a protective coating.

Belzona solution restored sealing on flange face without heat avoiding further damage to the Teflon lining. Use of Belzona® 4341 provided acid resistance to the repair.
