BELZONA FLOOR UPGRADE PROVIDES ENVIRONMENTAL PROTECTION

ID: 1340

Customer Location: Telecom company, Montreal, Canada
Application Date: February 2009

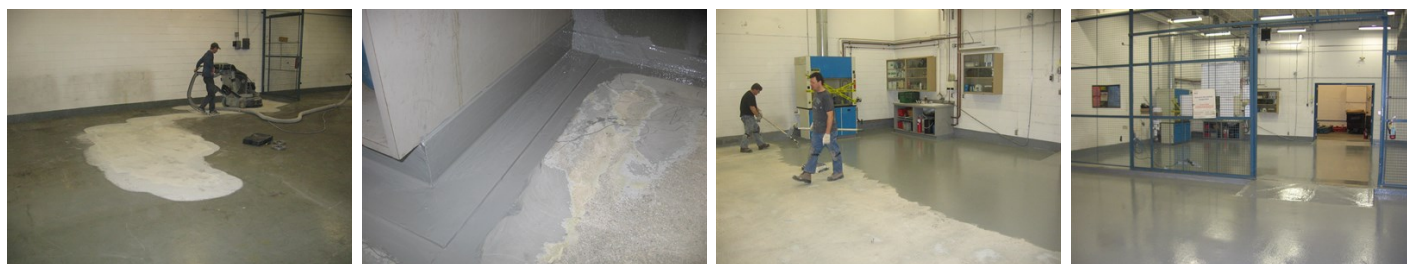
Photograph Descriptions

Original coating worn, not bonded in many areas and did not meet environmental requirements. System needs to contain potential spills or leaks.

- * Floor being abraded ,
- * Aluminium angles sealed with Belzona® 1121 ,
- * Belzona® 5811 being applied ,
- * Completed application ,

Application was carried out in accordance with Belzona Know-How System Leaflet FPA-3. Aluminum angles were bonded to wall/floor junction to create sealed coving prior to coating entire area with Belzona 5811
