# BELZONA RESEATS WEAR RINGS WITHOUT MACHINING

ID: 1341

Industry: Water / Wastewater  
Application: CEP-Centrifugal Pumps  
Substrate: Cast Iron  
Products: \* Belzona® 1121 (Super XL Metal) ,

Customer Location: Water treatment plant, Canada  
Application Date: March 2006

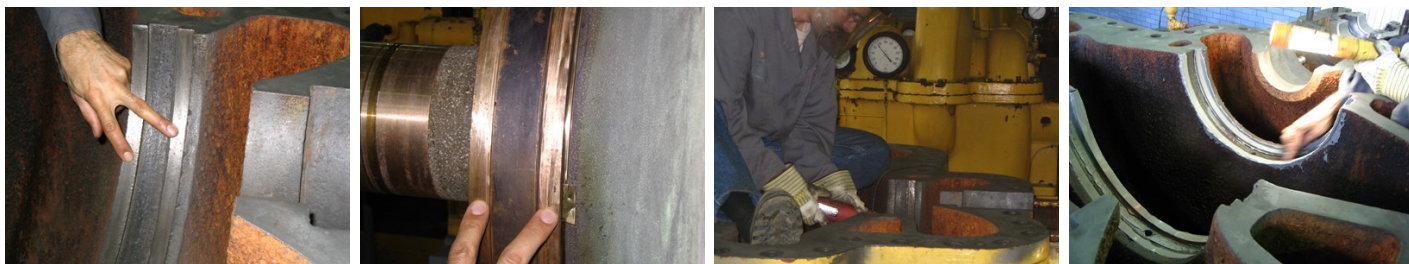
## Photograph Descriptions

*Erosion of wear ring seats caused vibration to the pump which needed repairs on site.*

- \* The wear ring seart ,
- \* Release Agent applied to wear rings assembled on impellor ,
- \* Surface preparation underway ,
- \* Final result: no machining required ,

Application was carried out in accordance with Belzona Know-How System Leaflet CEP-2. The wear rings were located on the rotating element and used as former for the seats.

Belzona® 1121 allowed rebuilding of the wear ring seats to the original profile without machining. Belzona® 1121 is solvent free and does not shrink during cure allowing exact forming of the seat. Also being an insulator Belzona® 1121 eliminates any future galvanic corrosion.
