BELZONA RESEATS WEAR RINGS WITHOUT MACHINING

Industry: Water / Wastewater
Application: CEP-Centrifugal Pumps
Substrate: Cast Iron
Products: * Belzona® 1121 (Super XL Metal) ,

Customer Location: Water treatment plant, Canada
Application Date: March 2006

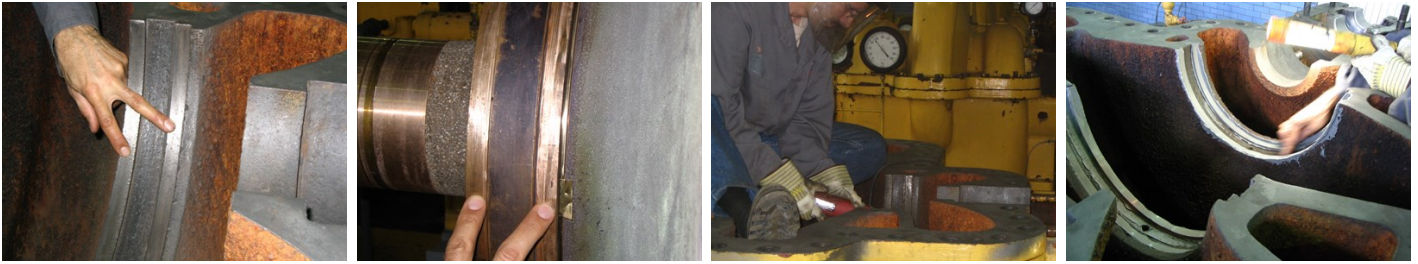
Photograph Descriptions

Erosion of wear ring seats caused vibration to the pump which needed repairs on site.

- * The wear ring seat ,
- * Release Agent applied to wear rings assembled on impellor ,
- * Surface preparation underway ,
- * Final result: no machining required ,

Application was carried out in accordance with Belzona Know-How System Leaflet CEP-2. The wear rings were located on the rotating element and used as former for the seats.

Belzona® 1121 allowed rebuilding of the wear ring seats to the original profile without machining. Belzona® 1121 is solvent free and does not shrink during cure allowing exact forming of the seat. Also being an insulator Belzona® 1121 eliminates any future galvanic corrosion.
