BELZONA KEEPS GARAGE SAFE AND CLEAN

ID: 1343

Industry: Buildings & Structures
Application: FPA-Floor Problem Areas
Substrate: Concrete
Products: * Belzona® 5231 (SG Laminate) ,

Customer Location: City Authority, Canada
Application Date: October 2007

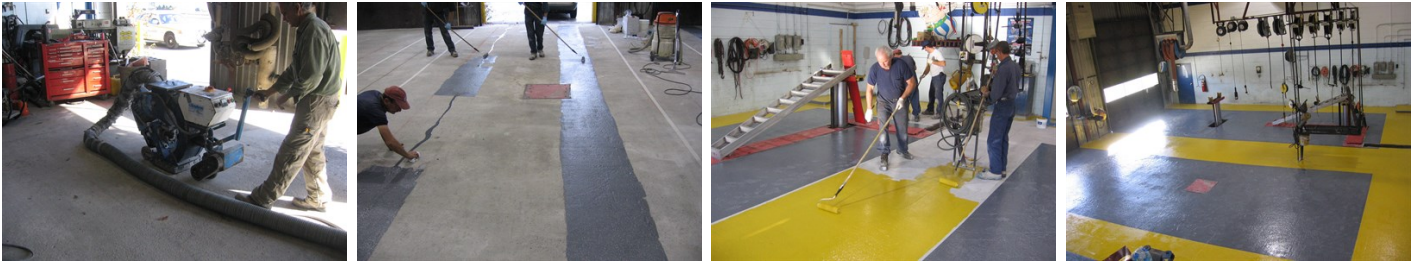
Photograph Descriptions

The original floor coating lasted only 12 months and cleaning the surface was a big problem because of the rough surface.

- * Surface preparation using Blastrac ,
- * Application of Belzona® 5231 gray (3 coats) ,
- * Application of Belzona® 5231 yellow ,
- * Completed application, clean and safe ,

Application was carried out in accordance with Belzona Know-How System Leaflet FPA-3. The concrete was abraded to remove the existing coating and profile the concrete. Areas masked off and Belzona® 5231 Yellow and Gray used for demarcation.

For our customer it was very important that the Belzona® 5231 would resist chemicals, especially oil. They also required that the surface was anti-slip. After 2 years in service only small touch-ups were done due to large volume of traffic in garage. Customer very satisfied and proud of the new look. They recommended our solution to the fire department.
