BELZONA FIXES DRAINAGE PROBLEM

Customer Location: Office Building, Ontario Canada
Application Date: May, 2009

Parking garage storm drain

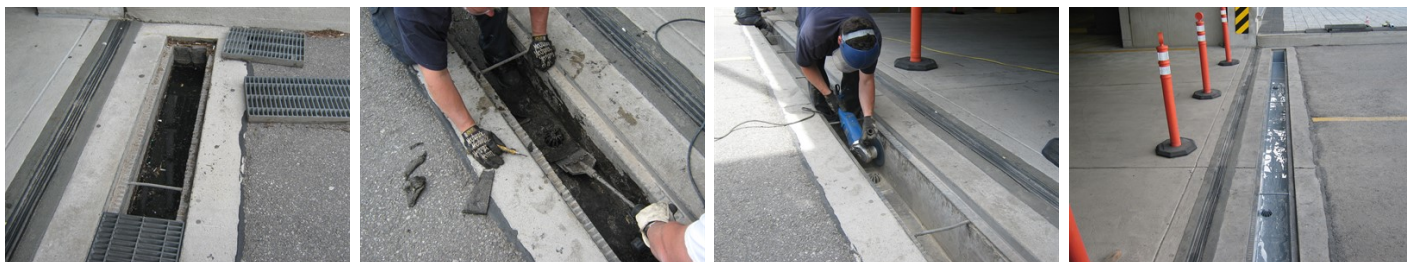
Photograph Descriptions

Previously installed coating system had failed and was stopping the water or anything else from draining out.

- * Water and trash not able to escape ,
- * Removing the old system ,
- * Grinding back to white concrete ,
- * Belzona® 5811 applied ,

Application was carried out in accordance with Belzona Know-How System Leaflet FPA-3. The failed coating was ground out to expose clean concrete before application of the Belzona® 5811.
