BELZONA RECONSTRUCTS STREET SWEEPER FAN

ID: 1348

Fan from a Busher type sweeper truck

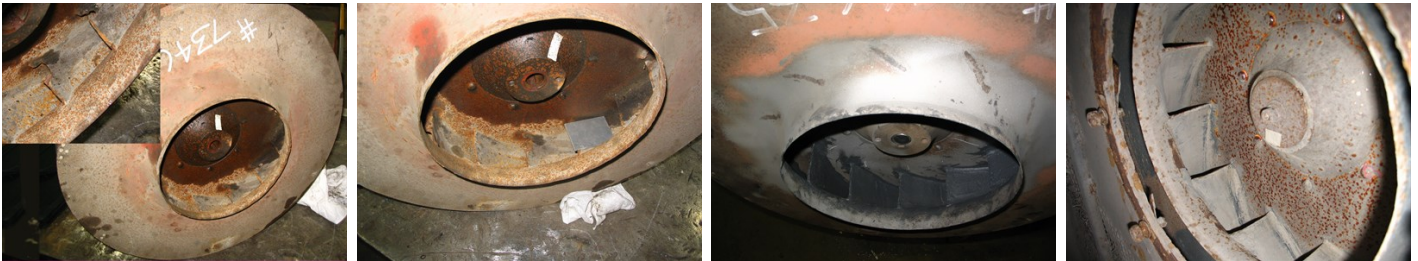
Photograph Descriptions

Wear on the blades of the fan. Customer wanted to avoid replacing the part.

- * Overall view of the fan and the wear on the blades ,
- * Steel plate being shaped in place ,
- * Plate being placed and coated with the Belzona 1311 ,
- * Inspection after 3 years shows no significant wear ,

Application was carried out in accordance with Belzona Know-How System Leaflet FBC-15. Steel plates were prepared for each blade to give back some structure. These plate were bonded in with the Belzona

The customer saved \$4000 from an investment of only \$400 in Belzona because the fan didn't need to be replaced. An inspection 3 years later showed no significant wear.
