# STREET SWEEPER FAN PROTECTED WITH BELZONA

ID: 1350

Industry: *General Industry*  
Application: *FBC-Fans, Blowers and Compressors*

Customer Location: *Local municipality, Québec Canada*  
Application Date: *May, 2006*

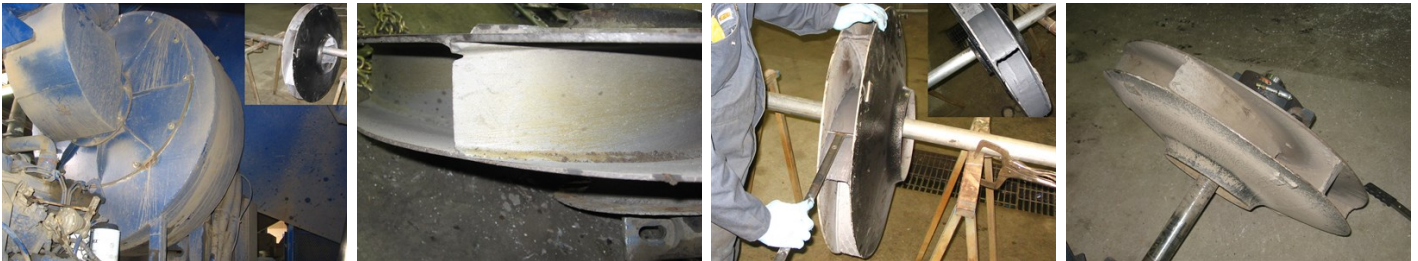
## Photograph Descriptions

*The blades on the fan are submitted to severe abrasion caused by solid particles entering the street sweeper.*

- \* Location of the fan on the vehicle ,
- \* View of the damage to the fan ,
- \* Application of Belzona® 1311. The fan needs dynamic balancing before being used ,
- \* The inspection after one year shows the Belzona® 1311 in excellent shape ,

Application carried out in accordance with Belzona Know-How System Leaflet FBC-15. Expanded metal was used with the Belzona to re-create correct profiles.

The customer invested in 2 units of Belzona® 1311 and saved on a brand new fan which would have cost \$4000.00. After 500 hours, one season, the fan is in excellent condition and no touch up was necessary.
