Belzona Waterproofs Sunroom Roof

Application: RPA-Roof Problem Areas

Customer Location: Residential Roof in Ontario

Application Date: June, 2009

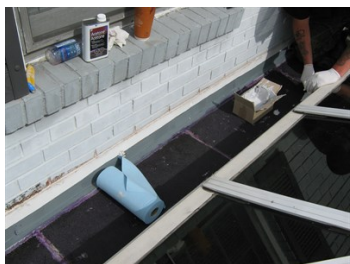
- * Applying Belzona® 3911 (Conditioner) ,
- * Initial application of Belzona® 3111 incorporating Reinforcing sheet in 1st Coat ,
- * & 4 Finished application ,

Using modified Belzona Know-How Systems Leaflet RPA-1, a fully reinforced Belzona® 3111 System was applied.
