BELZONA PROTECTS HEAT EXCHANGER HEAD

ID: 1355

Industry: Chemical & Petrochemical
Application: HEX-Heat Exchangers
Substrate: Carbon steel
Products: * Belzona® 1391 (Ceramic HT) ,

Customer Location: Chemical plant - Gulf Coast, USA.
Application Date: August 2009

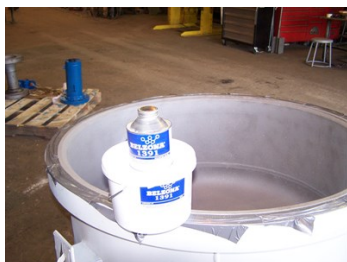
Severe corrosion occurring due to source water. corrosion rate estimated at 0.05" (1.25mm) per year.

- * ,
- * The rapid metal loss through corrosion clearly evident ,
- * Surface preparation completed ,
- * Close up of application ,
- * Completed head ,
- * ,
- * ,

Application was carried out in accordance with Belzona Know-How System Leaflet HEX-3.
