# BELZONA PROTECTS HEAT EXCHANGER HEAD

ID: 1355

Customer Location: Chemical plant - Gulf Coast, USA.  
Application Date: August 2009

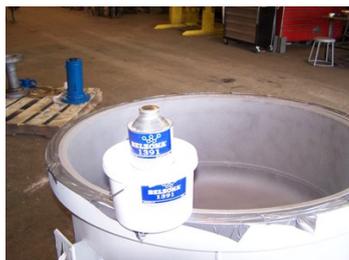
Severe corrosion occurring due to source water. corrosion rate estimated at 0.05" (1.25mm) per year.

- \* ,
- \* The rapid metal loss through corrosion clearly evident ,
- \* Surface preparation completed ,
- \* Close up of application ,
- \* Completed head ,
- \* ,
- \* ,

Application was carried out in accordance with Belzona Know-How System Leaflet HEX-3.
