BELZONA REPAIRS MAIN COOLING WATER SYSTEM FLANGE

ID: 1360

Customer Location: Nuclear Power Station, UK
Application Date: September 2009

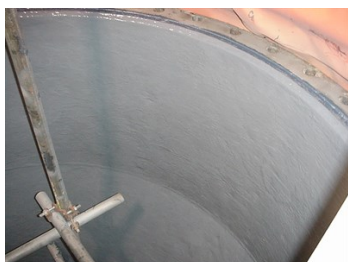
- * Belzona® 1321 coating on puddle pipe ,
- * Application of the Belzona® 1111 ,
- * Machining of the cured Belzona® 1111 ,
- * The completed application ,

This application follows the successful coating of the pipe internals with Belzona® 1321 in 2006. After 3 years this coating had been found to be in excellent condition, when this problem arose Belzona was the first and obvious choice. Belzona has been used many times to repair damaged flanges. The only alternative available to the client was to prefabricate the spool which represented unacceptable down-time.

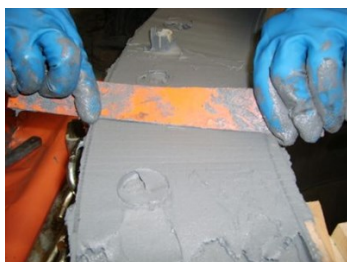
A new spool had been manufactured to connect the intake pipe to the rest of the cooling water system. During welding, the flange on this spool had become warped and following the subsequent machining was found to be up to 9mm undersized.

The application was carried out in accordance with Belzona Know-How System Leaflet VPF-13. After applying the Belzona proud, on-site machining was used to achieve correct dimensions.

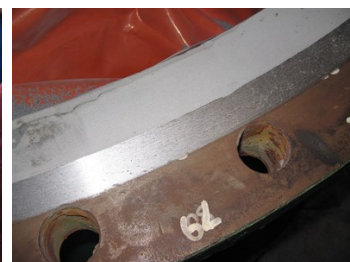
Flange on seawater intake pipe of cooling system for nuclear power station
