BELZONA RESTORES RIVER WATER PUMP

ID: 1362

Application: CEP-Centrifugal Pumps

Customer Location: Water treatment works, Iowa

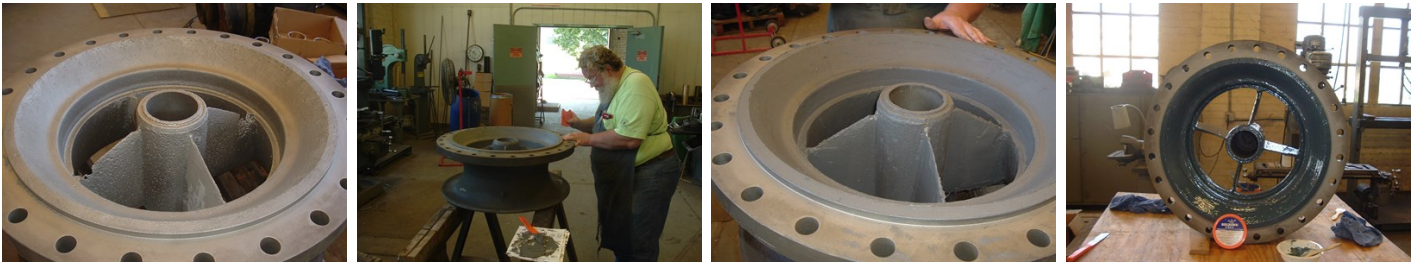
Photograph Descriptions

Erosion corrosion caused by sand and solids drawn from the river.

- * Damaged area on pump ,
- * Repairs underway with Belzona® 1111 ,
- * Rebuild completed with Belzona® 1111 ,
- * Completed application after application of Belzona® 1321 ,

Application was carried out in accordance with Belzona Know-How System Leaflets CEP-3 and -5

Belzona was chosen due to years of successful pump repairs with this customer. The pump was salvaged using around \$1,000 of Belzona materials, a fraction of the replacement cost.
