PUMP DIFFUSER REPAIR SURPASSES ALL EXPECTATIONS WITH BELZONA

ID: 1368

Customer Location: National Electricity Provider, Malta
Application Date: May 2000

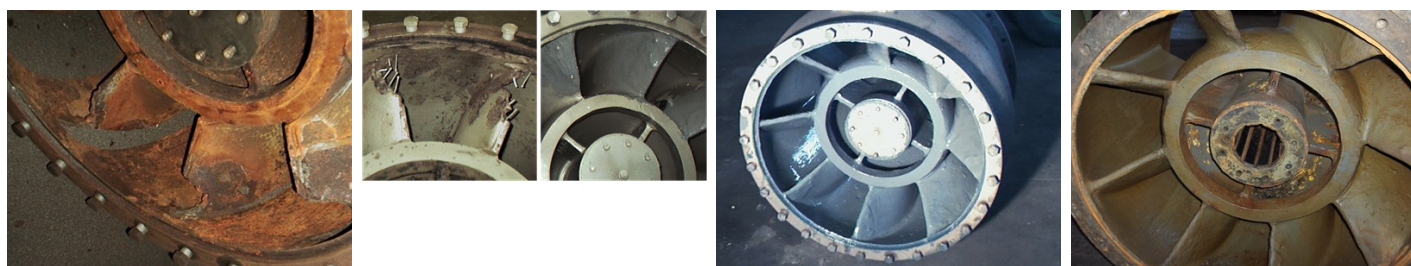
Photograph Descriptions

Efficiency losses and pump breakdown due to severe erosion-corrosion of the single vertical axial flow pump (7090 m³/h). Prior to the Belzona solution, the client had to replace the pump components annually. As a significant local electricity supplier, downtime of this critical equipment caused major problems.

- * Condition of the pump diffuser after 1 year in service ,
- * Rebuilding of the vane profiles ,
- * The finished application ,
- * Application after 9 years service ,

The application was carried out in accordance with Belzona Know-How System Leaflets CEP-1, CEP-3 and CEP-4.

The customer was surprised that the eroded equipment could be repaired and delighted with the vastly improved reliability and performance. The pump casing and suction bell were also coated and protected internally and externally. After 9 years in service,

the coating was found to still be in excellent condition.
