# BELZONA TO THE RESCUE ON-BOARD U.S. NAVY CARRIER

ID: 138

Marine evaporator doors on a Helicopter Carrier

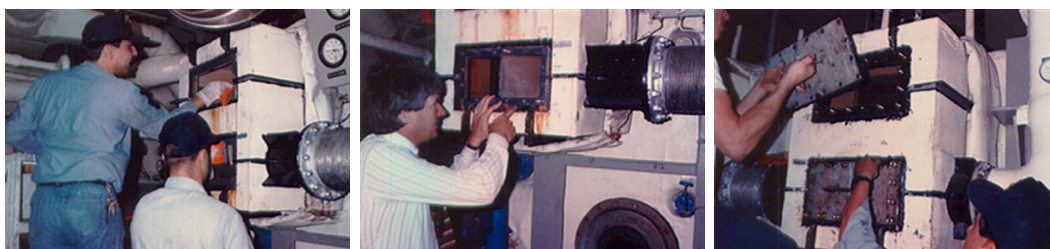
*The evaporator doors were leaking and threaded holes in the evaporator casing for the door "hold-down" had badly corroded from contact with brine solution.*

- \* Applying Belzona® 1111 to a flange ,
- \* Inspecting the recently reformed flange surface ,
- \* Forming custom gaskets in place with Belzona® 2111 ,

Application was carried out in accordance with Belzona Know-How Leaflets GSS-1 and GSS-8.

The repair was carried out in one afternoon, with the ship at the pier, saving the U.S. Navy an estimated \$100,000.
