BELZONA TO THE RESCUE ON-BOARD U.S. NAVY CARRIER

ID: 138

Marine evaporator doors on a Helicopter Carrier

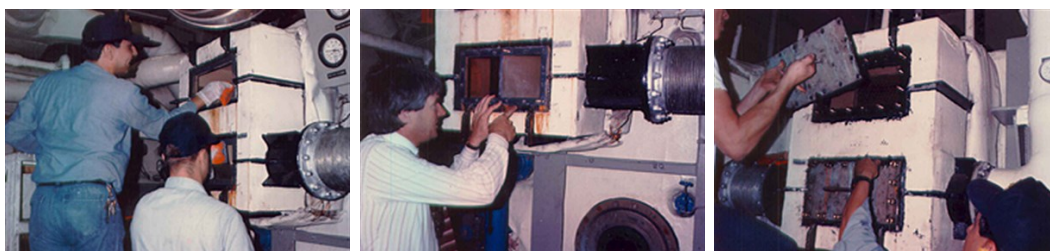
Photograph Descriptions

The evaporator doors were leaking and threaded holes in the evaporator casing for the door "hold-down" had badly corroded from contact with brine solution.

- * Applying Belzona® 1111 to a flange ,
- * Inspecting the recently reformed flange surface ,
- * Forming custom gaskets in place with Belzona® 2111 ,

Application was carried out in accordance with Belzona Know-How Leaflets GSS-1 and GSS-8.

The repair was carried out in one afternoon, with the ship at the pier, saving the U.S. Navy an estimated \$100,000.
