# BELZONA KITCHEN REPAIR KEEPS THE STUDENTS GOING

Industry: *Buildings & Structures*  
Application: *FPA-Floor Problem Areas*  
Substrate: *Metal, concrete and tiles*  
Products: *\* Belzona® 4111 (Magma Quartz) ,*

Customer Location: *University, France*  
Application Date: *June 2004*

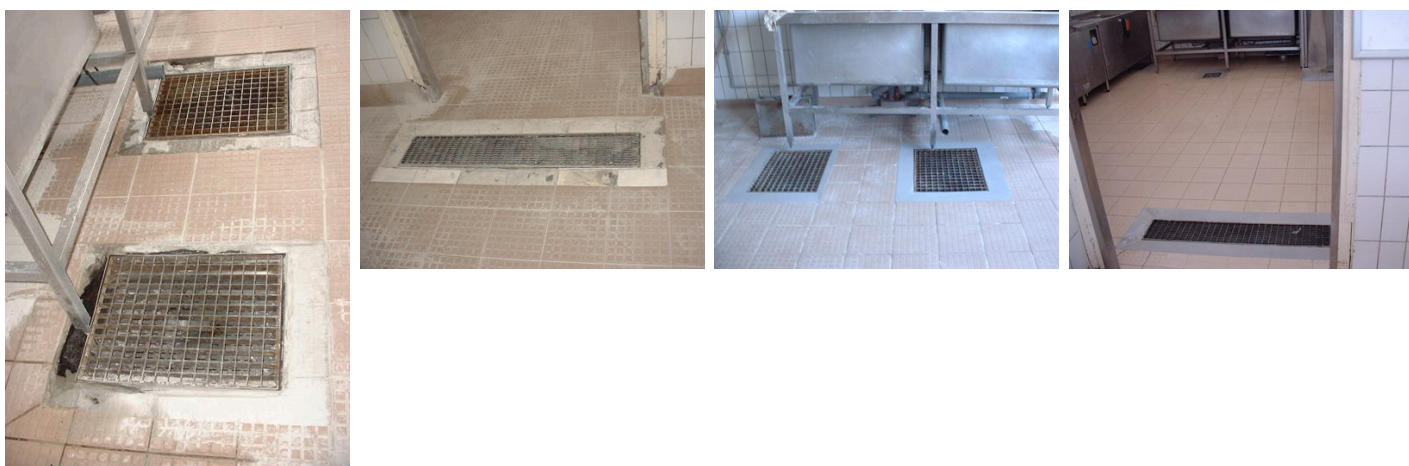
*The tiles were degraded around the stainless steel grate. Following a health and safety inspection, the hygiene of the kitchen was reported so urgent action needed to be taken.*

- \* Application situation 1 before repair ,
- \* Application situation 2 before repair ,
- \* Application situation 1 after repair ,
- \* Application situation 2 after repair ,

The application was carried out following the Belzona Know-How System Leaflet FPA-1.

tile). The easy to clean surface, proven to be a hygienic solution. It is also resistant to the cleaning liquids used. The Belzona® 4111 is resistant to the pedestrian & trolley traffic in this environment and after 5 years in service, the repair is still in perfect condition.
