BELZONA KITCHEN REPAIR KEEPS THE STUDENTS GOING

ID: 1381

Industry: Buildings & Structures
Application: FPA-Floor Problem Areas
Substrate: Metal, concrete and tiles
Products: * Belzona® 4111 (Magma Quartz) ,

Customer Location: University, France
Application Date: June 2004

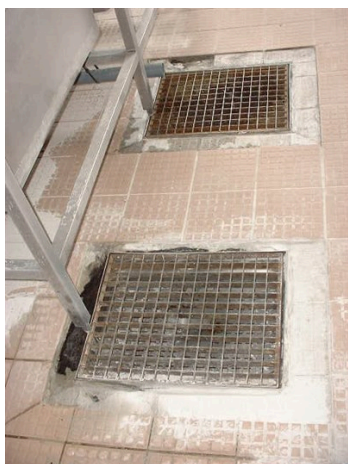
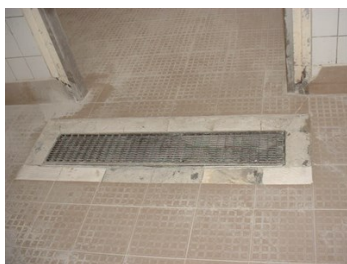
The tiles were degraded around the stainless steel grate. Following a health and safety inspection, the hygiene of the kitchen was reported so urgent action needed to be taken.

- * Application situation 1 before repair ,
- * Application situation 2 before repair ,
- * Application situation 1 after repair ,
- * Application situation 2 after repair ,

The application was carried out following the Belzona Know-How System Leaflet FPA-1.

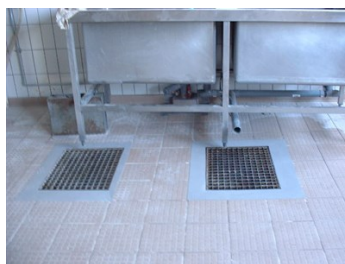
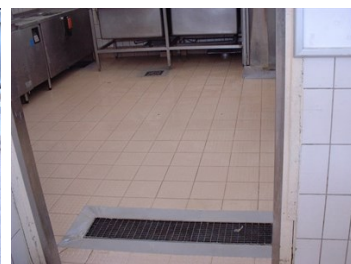
tile). The easy to clean surface, proven to be a hygienic solution. It is also resistant to the cleaning liquids used. The Belzona® 4111 is resistant to the pedestrian & trolley traffic in this environment and after 5 years in service, the repair is still in perfect condition.
