# BELZONA KITCHEN REPAIR KEEPS THE STUDENTS GOING

ID: 1381

Industry: Buildings & Structures  
Application: FPA-Floor Problem Areas  
Substrate: Metal, concrete and tiles  
Products: \* Belzona® 4111 (Magma Quartz) ,

Customer Location: University, France  
Application Date: June 2004

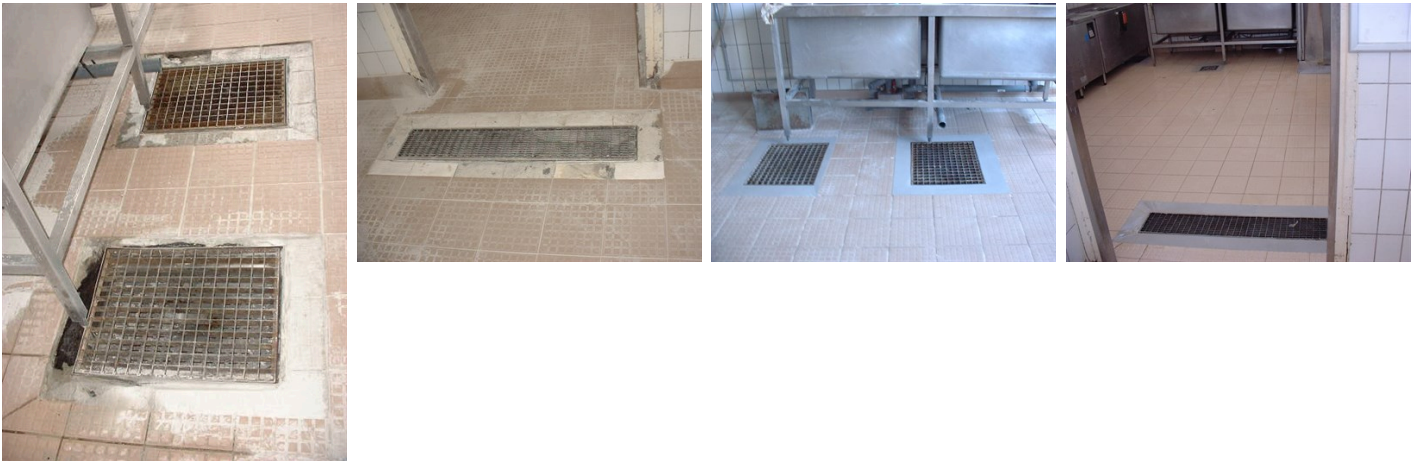
The tiles were degraded around the stainless steel grate. Following a health and safety inspection, the hygiene of the kitchen was reported so urgent action needed to be taken.

- \* Application situation 1 before repair ,
- \* Application situation 2 before repair ,
- \* Application situation 1 after repair ,
- \* Application situation 2 after repair ,

The application was carried out following the Belzona Know-How System Leaflet FPA-1.

tile). The easy to clean surface, proven to be a hygienic solution. It is also resistant to the cleaning liquids used. The Belzona® 4111 is resistant to the pedestrian & trolley traffic in this environment and after 5 years in service, the repair is still in perfect condition.
