BELZONA PROTECTS HEAT EXCHANGER TUBE SHEETS

Customer Location: Chemical Plant, Mexico

Heat exchanger tube sheets in Chemical plant.

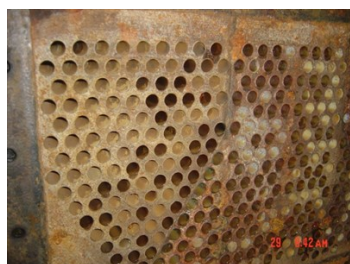
Erosion corrosion protection required on tube sheets to prevent further loss of metal that could otherwise lead to leakage, loss of efficiency and contamination.

- * Corroded tube sheet ,
- * After grit blasting ,
- * 1st coat of Belzona® 1321 ,
- * Completed application with corks removed from tubes ,
