# BELZONA REBUILDS BEARING PLATES ON VERTICAL BORER

Application Date: March 1997

Craven 90" dia. Vertical Borer

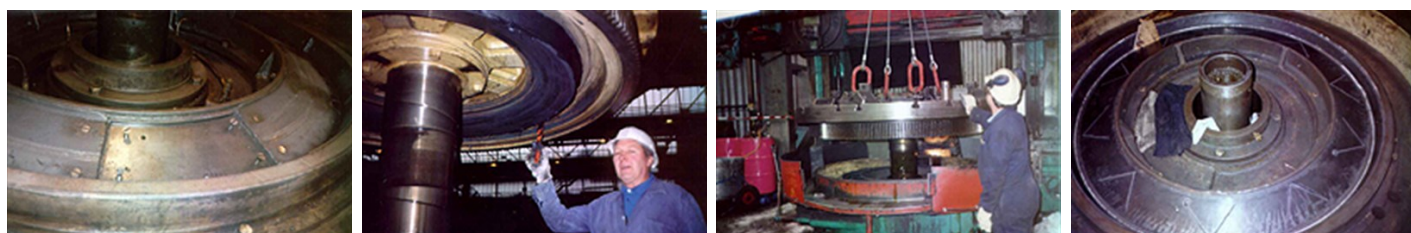
## Photograph Descriptions

White metal bearing plates badly worn/scored due to oil starvation. Manufacturer of this unit has ceased trading so replacement part is unobtainable.

- \* The problem area - excessive wear to white metal plates. ,
- \* Application of Belzona® 1131. ,
- \* Chuck going back into machine to form Belzona® 1131. ,
- \* The finished job with oil grooves cut into Belzona® 1131. ,

The application was carried out in accordance with Belzona Know-How Leaflet MPT-9.

The repaired machine now runs quieter and more smoothly, providing a higher standard of finish to machined components.
