# BELZONA RESTORES HYDROGEN COOLER ENDS

ID: 1390

Customer Location: Power Station, Ontario  
Application Date: November 2009

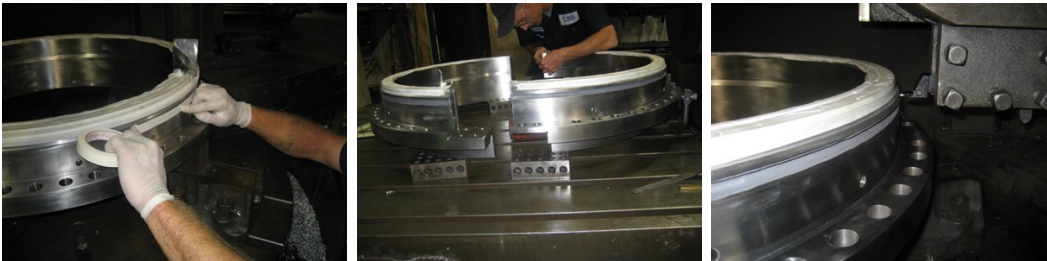
## Photograph Descriptions

Seals had become out of round and as a result gas leaks had started.

- \* Unit set-up on turntable and upper and lower outside diameters masked off ,
- \* Belzona® 1111 applied to build up the groove to the desired over-thickness ,
- \* Seals ready to be machined to correct tolerance ,

Application carried out in accordance with Belzona Know-How System Leaflet MPT-9. Units are set up on a turntable and Belzona applied to rebuild groove before being re-machined to tolerance.
