# BELZONA DOUBLES PUMP SERVICE LIFE

**Industry:** Chemical & Petrochemical  
**Application:** CEP-Centrifugal Pumps  
**Substrate:** Cast Iron  
**Products:** \* Belzona 1311 (Ceramic R-Metal) ,  
\* Belzona 1391 (Ceramic HT) ,

**Customer Location:** Petrochemical Plant, Ukraine  
**Application Date:** December 1999

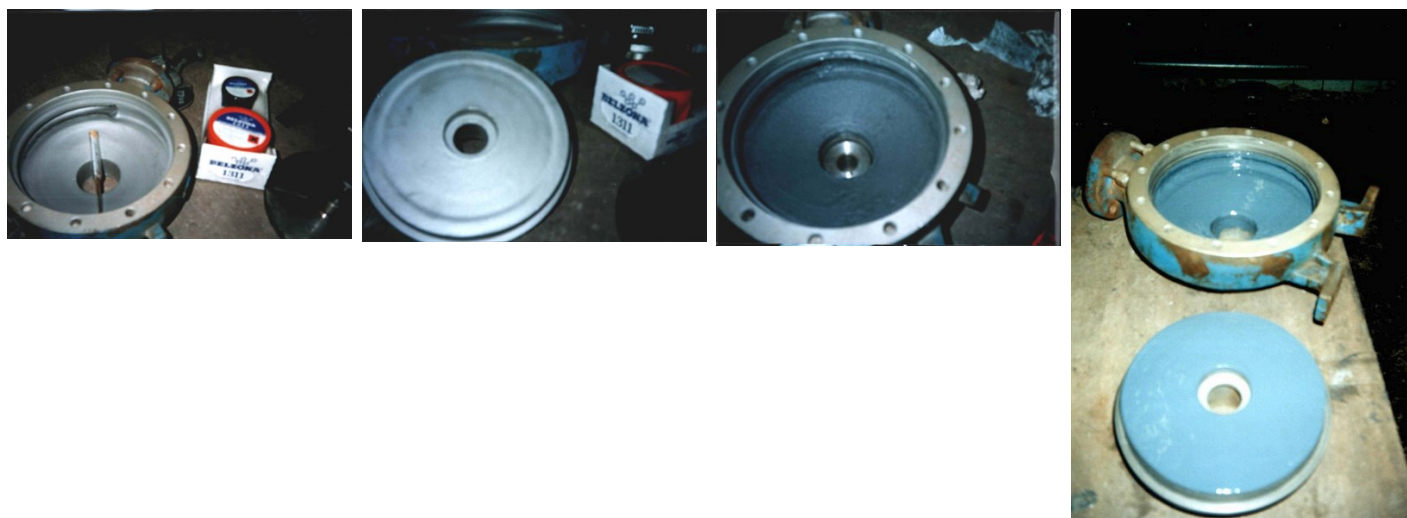
Due to crystallization of paraffin erosion-corrosion damage occurred on the case of the pump and cover. Acquisition of certain parts of the pump was not possible.

- \* Grit blasted casing ,
- \* Pump cover before rebuilding ,
- \* Belzona® 1311 applied to casing ,
- \* Completed application ,

The application was carried out in accordance with Belzona Know-How System Leaflets CEP-5 and -3. areas were rebuilt using

forming techniques.

Repair was done within 8 hours. In 3 days the pump was returned to service. Using Belzona allowed the customer avoid having to purchase new pump parts. this application increased average service life of such pumps from 4368 hours to 9168 hours.
