BAROMETRIC CONDENSER PROTECTED WITH BELZONA

ID: 1397

Customer Location: Oil Refinery, Pennsylvania USA
Application Date: November 2008

New Barometric Condenser for Major East Coast Oil Refinery

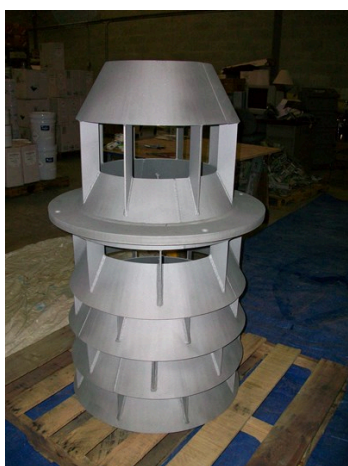
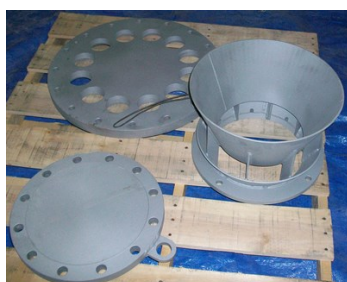
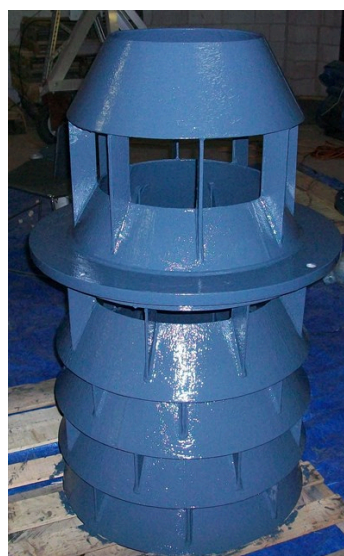
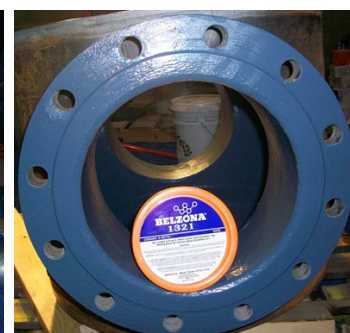
Photograph Descriptions

Previous uncoated condenser was destroyed by erosion/corrosion. A new condenser was manufactured and the decision made to protect it with Belzona.

- * White metal blast ,
- * Additional components after blasting ,
- * Condenser coated ,
- * Coated flange face ,

Application was carried out in accordance with Belzona Know-How System Leaflet HEX-3.

Belzona was chosen for its proven resistance to corrosion and erosion and its cost effectiveness. The alternative to fabricate the condenser out of alloy was more expensive and the lead time of over 6 months was unacceptable to the client.
