# BAROMETRIC CONDENSER PROTECTED WITH BELZONA

ID: 1397

Customer Location: Oil Refinery, Pennsylvania USA  
Application Date: November 2008

New Barometric Condenser for Major East Coast Oil Refinery

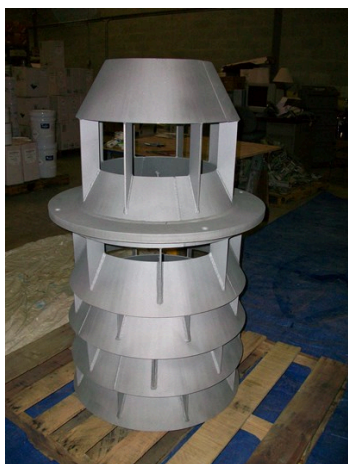
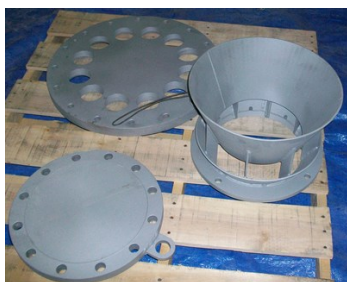
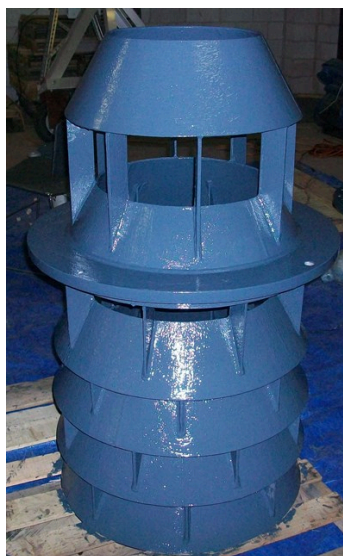
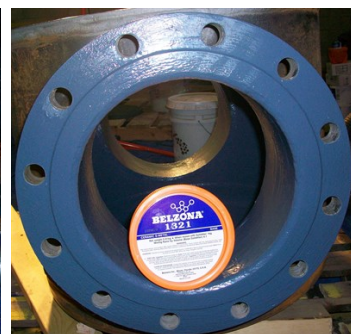
## Photograph Descriptions

Previous uncoated condenser was destroyed by erosion/corrosion. A new condenser was manufactured and the decision made to protect it with Belzona.

- \* White metal blast ,
- \* Additional components after blasting ,
- \* Condenser coated ,
- \* Coated flange face ,

Application was carried out in accordance with Belzona Know-How System Leaflet HEX-3.

Belzona was chosen for its proven resistance to corrosion and erosion and its cost effectiveness. The alternative to fabricate the condenser out of alloy was more expensive and the lead time of over 6 months was unacceptable to the client.
