BELZONA KEEPS HOSPITAL LAUNDRY BILLS DOWN

Industry: *General Industry*
Application: *VPF-Valves, Pipes and Fittings*
Substrate: *Rubber*
Products: ** Belzona® 2211 (MP Hi-Build Elastomer) ,*

Customer Location: *Hospital*
Application Date: *Ongoing since 1994*

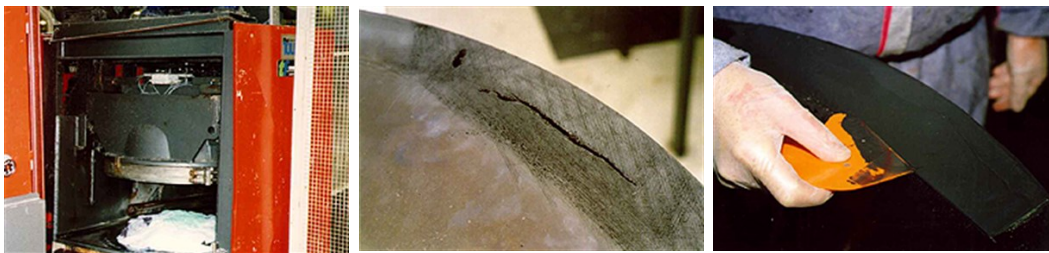
Photograph Descriptions

Wear and tear in service causes splits, in addition to mechanical damage caused by sharp objects left in clothing (a common occurrence).

- * The laundry press in operation ,
- * Typical split prepared and ready to have Belzona® applied ,
- * Completing the Belzona® 2211 application ,

Press used to squeeze water from laundry prior to drying. They operate at pressures up to 270 bar.

Application was carried out in accordance with Belzona System leaflet VPF-5.

Typical Belzona repairs cost £10-20 as opposed to a new diaphragm at over £1400. At this hospital some diaphragms have been repaired 5 and 6 times.
