BELZONA KEEPS HOSPITAL LAUNDRY BILLS DOWN

ID: 140

Application: VPF-Valves, Pipes and Fittings

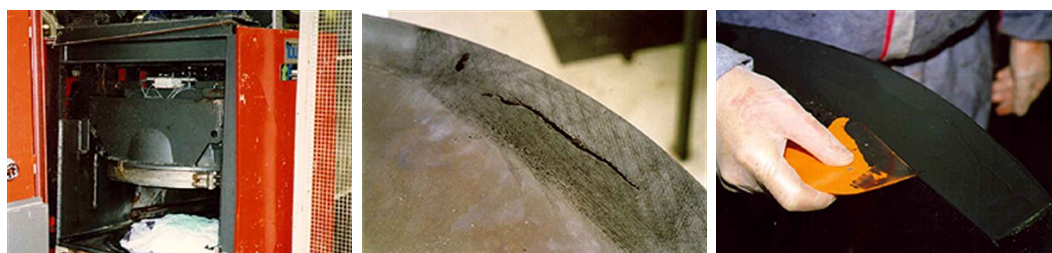
Photograph Descriptions

Wear and tear in service causes splits, in addition to mechanical damage caused by sharp objects left in clothing (a common occurrence).

- * The laundry press in operation ,
- * Typical split prepared and ready to have Belzona® applied ,
- * Completing the Belzona® 2211 application ,

Press used to squeeze water from laundry prior to drying. They operate at pressures up to 270 bar.

Application was carried out in accordance with Belzona System leaflet VPF-5.

Typical Belzona repairs cost £10-20 as opposed to a new diaphragm at over £1400. At this hospital some diaphragms have been repaired 5 and 6 times.
