# BELZONA SAVES MONEY ON OIL-COOLER REPAIRS

Industry: Power  
Application: HEX-Heat Exchangers  
Substrate: Carbon Steel  
Products: \* Belzona® 1111 (Super Metal) ,  
\* Belzona® 1391 (Ceramic HT) ,

Customer Location: Nuclear Power Plant, Russia  
Application Date: 2005

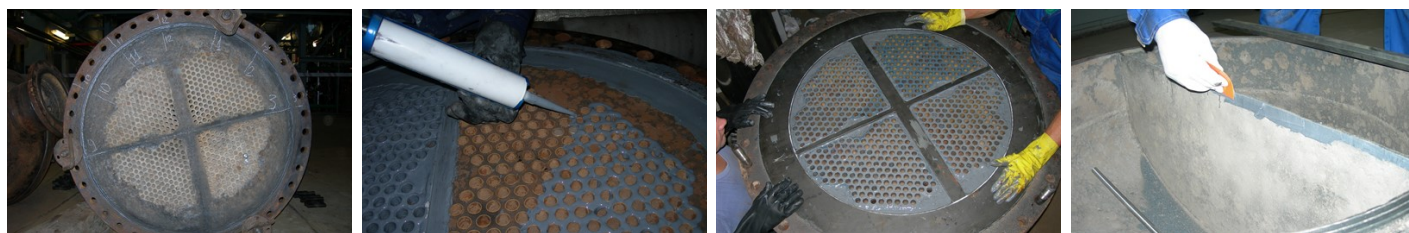
*Due to the high temperature liquids, the sealing areas were eroded and corroded. Flanges, tubesheet and water box have been further damaged by corrosion.*

- \* Corroded tube sheet before application ,
- \* First coat of Belzona® 1391 ,
- \* Forming of sealed faces ,
- \* Rebuilding water box division bar with Belzona® 1111 ,

The repaired equipment was inspected in 2009 and showed no signs of corrosion or erosion. The Belzona system allowed full sealing on the previously corroded seal faces. Cost of these repairs is minimal in comparison with new equipment that would cost 80.000 €. A Testimonial letter from customer is available.
