BELZONA EXPANSION JOINT THREE YEARS ON

Industry: Buildings & Structures
Application: FPA-Floor Problem Areas
Substrate: Concrete
Products: * Belzona® 4111 (Magma Quartz) ,
* Belzona® 2211 (MP Hi-Build Elastomer) ,
* Belzona® 4411 (Granogrip) ,

Customer Location: Hospital, Charlotte, North Carolina, USA
Application Date: March, 2006

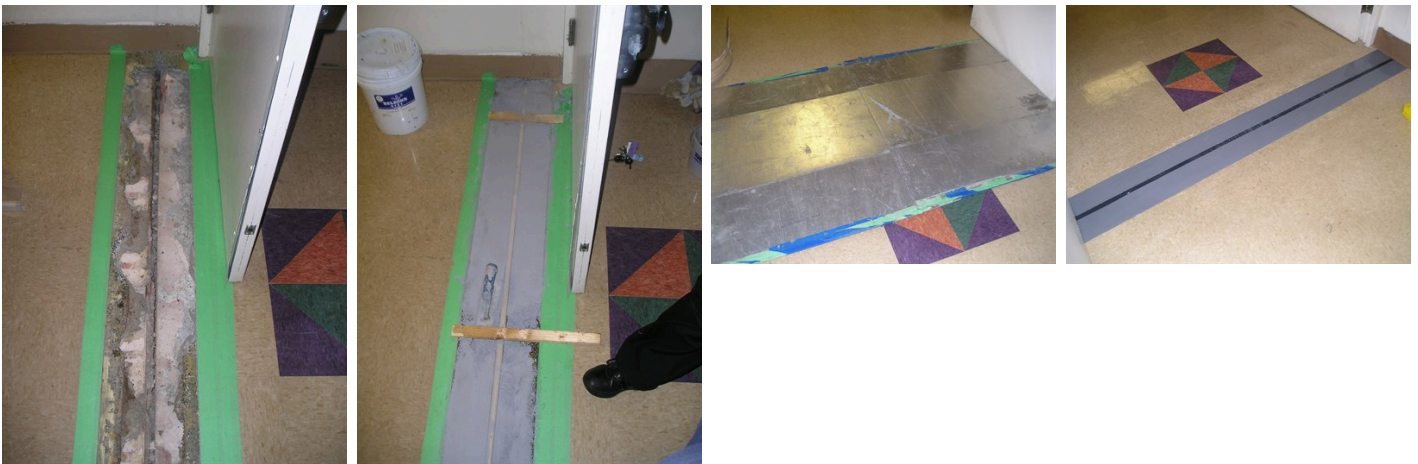
Photograph Descriptions

The expansion joint had failed and was causing a trip hazard, as well as making hospital guests uncomfortable when rolled in their beds or wheelchairs across the failed joint. Metal plate put over top was a trip and bump hazard.

- * Joint taken out and fresh concrete exposed ,
- * Belzona® 4111 troweled into place ,
- * Ramp used to cover joint while product is curing ,
- * Finished joint 3 years on ,

The Belzona application was carried out in accordance with Belzona Know-How System Leaflets FPA-5 & -6. The old metal joint was torn out and replaced with Belzona® 4111. A jig was used to provide the repair with the same height as the tile floor. After removing the joint former, Belzona® 2211 was used to seal the joint. Belzona® 4411 applied for aesthetics.
