BELZONA SOLVES KITCHEN TRIP HAZARD

ID: 1408

Industry: Buildings & Structures
Application: FPA-Floor Problem Areas
Substrate: Concrete, rubber and tile
Products: * Belzona® 4111 (Magma Quartz) ,

Customer Location: Hospital, Charlotte, North Carolina USA
Application Date: January, 2009

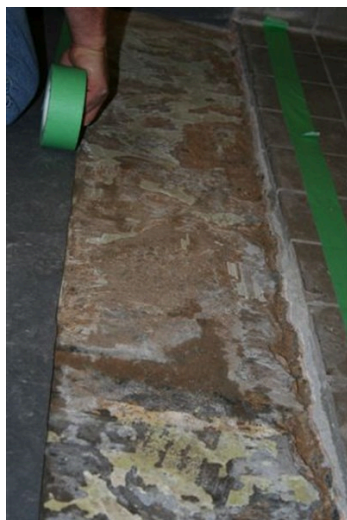
There is a big transition which was causing a trip hazard as well as limiting cart traffic.

- * Coin shows the transition step ,
- * Exposed concrete after rubber floor removal. ,
- * Applying the Belzona 4111 ,
- * The finished job ,

The application was carried out in accordance with Belzona Know-How System Leaflets FPA-1 & -5. The rubber floor was cut out so a slope could be made from the edge of the rubber floor to the tile so that a smooth transition could be created.
