BELZONA SOLVES KITCHEN TRIP HAZARD

ID: 1408

Customer Location: Hospital, Charlotte, North Carolina USA
Application Date: January, 2009

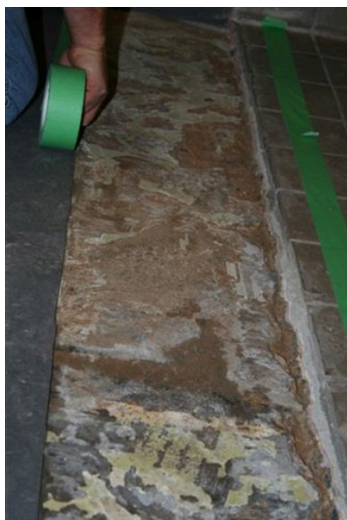
There is a big transition which was causing a trip hazard as well as limiting cart traffic.

- * Coin shows the transition step ,
- * Exposed concrete after rubber floor removal. ,
- * Applying the Belzona 4111 ,
- * The finished job ,
