IMPELLER AT NUCLEAR PLANT REPAIRED AND PROTECTED WITH BELZONA

ID: 1409

Industry: Power
Application: CEP-Centrifugal Pumps
Substrate: Aluminum Bronze
Products: * Belzona® 1341 (Supermetalgilde) ,
* Belzona® 1121 (Super XL-Metal) ,
* Belzona® 2141 (ACR Elastomer) ,

Customer Location: Nuclear Power Plant, North Carolina
Application Date: August, 2009

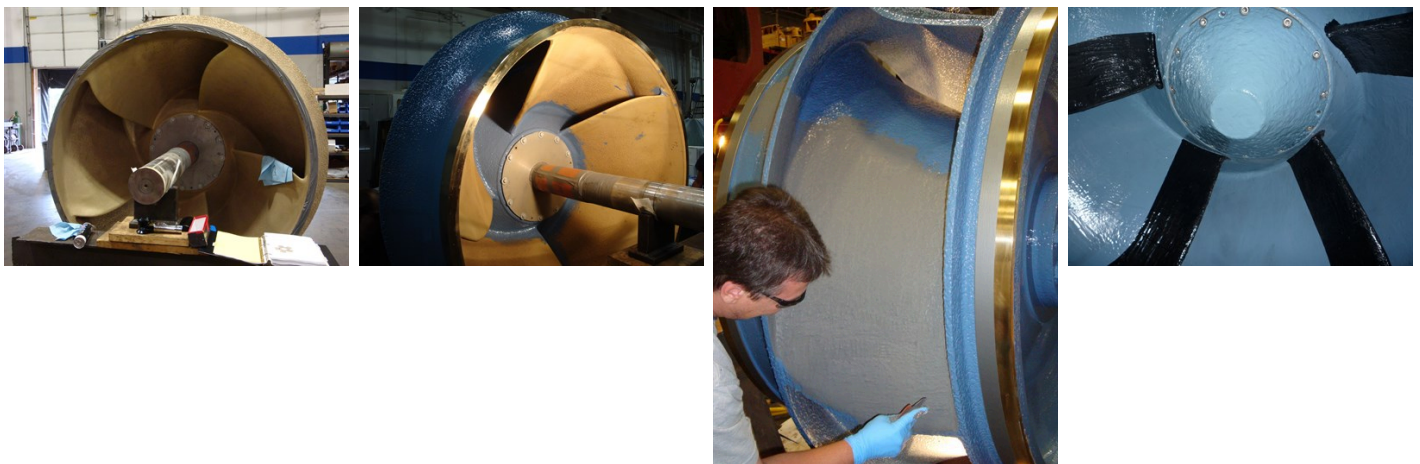
Photograph Descriptions

A combination of de-Aluminification over the surface of the impeller and cavitation at root of the vanes was causing a significant reduction in the efficiency of this pump.

- * Impeller before application of any product ,
- * Application of the 1st layer of Belzona® 1341 ,
- * Application of the smoothing layer of Belzona® 1121 ,
- * Belzona® 2141 applied to complete the job ,

The application was carried out in accordance with Belzona Know-How System Leaflets CEP-1, -3, -5 & -10. Belzona® 1121 used to smooth the surface prior to application of Belzona® 1341 system. Belzona® 2141 was then applied 8" on either side of the vanes to protect from cavitation.
