# BELZONA KEEPS METAL CHURNING

ID: 1410

Customer Location: *Metals Plant, North Carolina, USA*  
Application Date: *February, 2008*

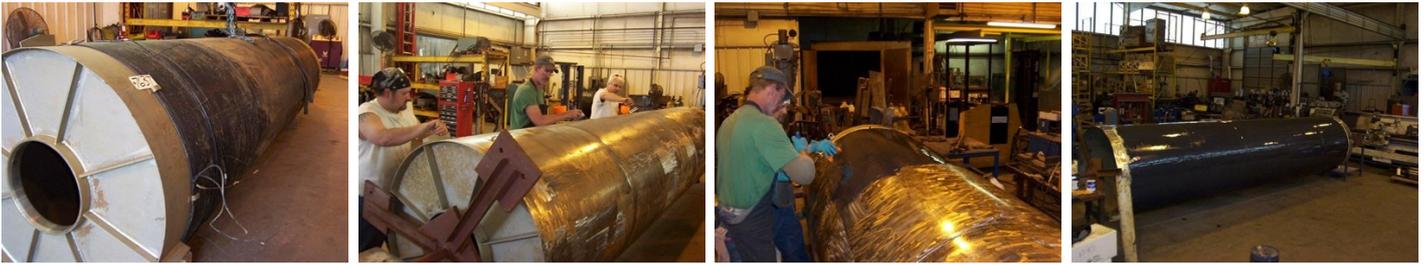
*Electrical shorts in the coil wrapped around the cylinder caused a loss of current responsible for producing the magnetic field used to stir the molten titanium.*

- \* Stirring jacket wrapped in coil. ,
- \* Cylinder prepared ready for application of first coat. ,
- \* First coat being applied. ,
- \* Cylinder after 18 months still "churning" away. ,

Application was carried out in accordance with Belzona Know-How System Leaflet GSS-1. Approximately one mile of #6 wire which supplied the current was removed. After surface preparation, one coat of Belzona® 2221 was applied, the coil was then re-wrapped, and a further coat of Belzona® 2221 was applied over the coil.
