CAVITATION PROTECTION FOR WATER PUMPS WITH BELZONA

Application: *CEP-Centrifugal Pumps*

Customer Location: *Water treatment plant, Egypt*

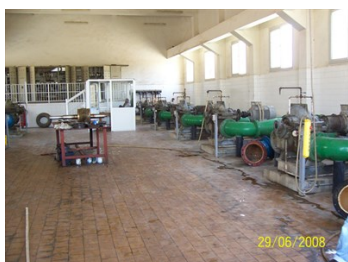
- * General view of the pumps ,
- * Erosion/Corrosion damage ,
- * The cavitation area after blasting ,
- * Completed application ,

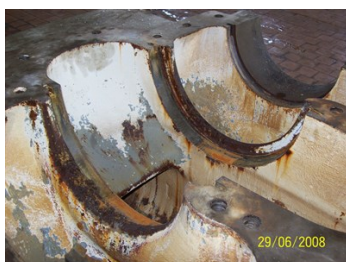
General erosion/corrosion damage and severe cavitation leads to reduced pump efficiency.
