BELZONA FACTORY APPLIED TO CHILLER

ID: 1418

Industry: Heating, Ventilation & Air Conditioning
Application: HEX-Heat Exchangers
Substrate: Carbon Steel
Products: * Belzona® 1111 (Super Metal) ,
* Belzona® 1321 (Ceramic S-Metal) ,

Customer Location: Manufacturing Facility, Texas USA
Application Date: 2009

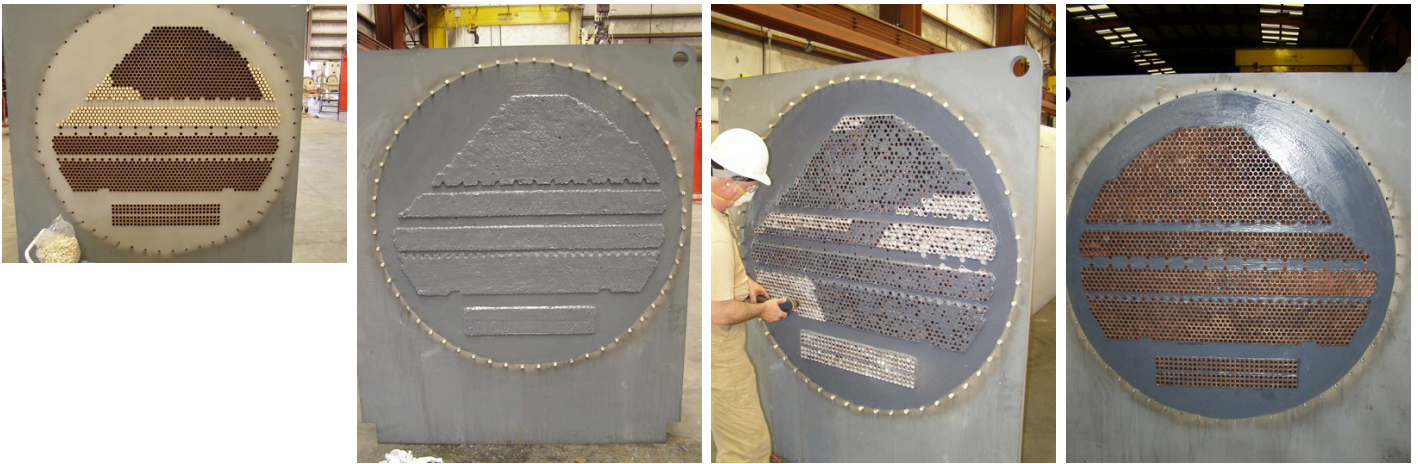
Photograph Descriptions

- * Corking of the tube sheet ,
- * Built-up tube sheet with one of coat of Belzona® 1321 applied ,
- * Corks punched in and tube ends being honed ,
- * Completed tube sheet ,

Application carried out in accordance with Belzona Know-How System Leaflets HEX-1 & -3. After corking tubes, Belzona® 1111 used to ensure the tubes are flush with the surface before applying the Belzona® 1321 system.
