# BELZONA® REFURBISHMENT OF VACUUM PUMP

Application: PDP-Positive Displacement Pumps

Customer Location: Australian brewery

Siemens Elmo vacuum pump from drum filter

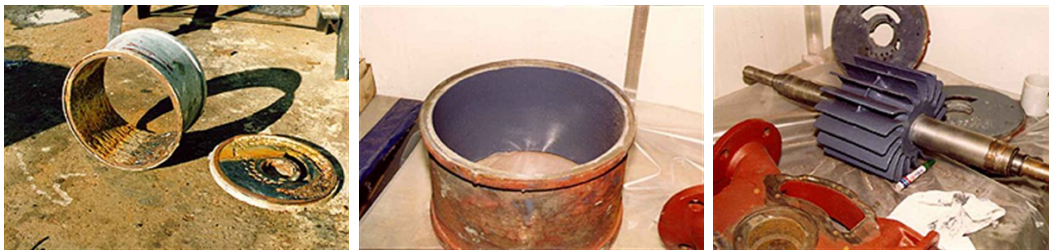
Severe erosion corrosion of port plates, body and rotor caused by poor quality sealing water resulting in corrosion, plus carry over of diatomaceous earth causing erosion.

- \* The degree of erosion corrosion clearly evident on the port plates and body ,
- \* The restored body ,
- \* The coated rotor with reformed port plates in background ,

Application was carried out in accordance with Belzona Know-How leaflets PDP-5 and FBC-11. Port plates were restored by forming correct dimensions and critical areas on the body were re-built and machined to size before coating with Belzona® 1321
