BOW THRUSTER REPAIR WITH BELZONA

ID: 1423

Bow thruster of cargo vessel

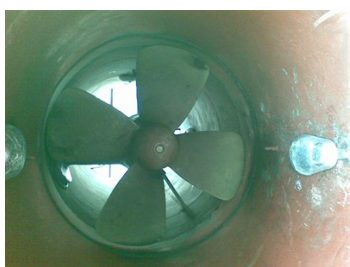
Erosion/corrosion effects made severe pitting damage to the whole bow thruster and supporting pillar due to bad cathodic protection.

- * General view of bow thruster ,
- * Belzona® 1311 used to rebuild damaged surface and restore profile ,
- * First coat of Belzona® 1321 applied ,
- * Second coat of Belzona® 1321 applied to complete application ,

Replacement of the badly eroded bow thruster body was planned for the next dry-dock but immediate replacement was not an option due to delivery time constraints. Belzona was chosen for its durable, fast and inexpensive application. The whole repair was done within a 48 hour period, restoring an even surface profile with additional protective coating for long erosion/corrosion resistance.
