BELZONA RESURFACES BRAKE TEST ROLLERS

Customer Location: State Road Transport Research Institute,
Ukraine

Rollers of the Brekon 131-4S type car brake testing rig.

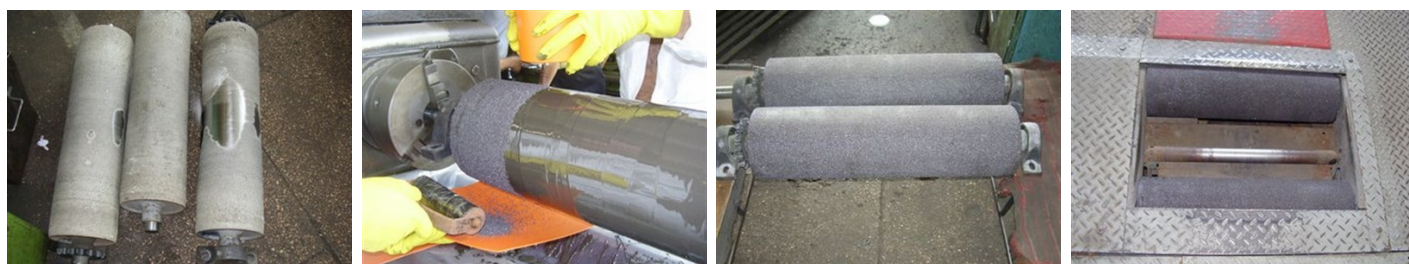
Photograph Descriptions

Worn original anti-slip coating on the brake rollers.

- * The worn brake test rollers ,
- * Application of Belzona Grip system ,
- * Completed application ,
- * Picture after 2 years in service and more than 12,000 brake tests ,

The application was carried out in accordance with Belzona Know-How System Leaflet SHM-12.

Belzona application avoided the replacement costs and outage of equipment. Between 2007 and 2009, more than 12.000 brake tests have been carried out, which was a very satisfactory result for the client. A Testimonial letter is available from the customer about this application.
