# BELZONA PROTECTS AUGER SCREWS AT CEMENT PLANT

Industry: *Cement*

Application: *SHM-Solids Handling Machinery*

Customer Location: *Cement Producer, Lithuania*

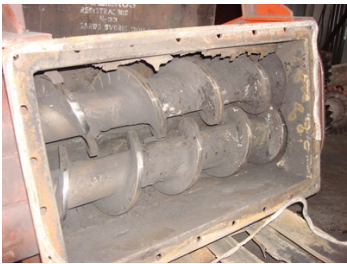
*The auger screws suffer severe abrasion and client needed an effective protection system.*

- \* General view of screws after 1 year in service ,
- \* The view after surface preparation ,
- \* Belzona® 1812 application on both sides of helical outer surfaces ,
- \* Belzona® 1321 application and completed job ,
