BELZONA PROTECTS AUGER SCREWS AT CEMENT PLANT

Application: *SHM-Solids Handling Machinery*

Customer Location: *Cement Producer, Lithuania*

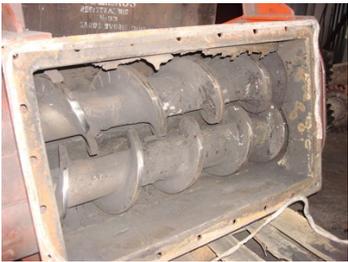
The auger screws suffer severe abrasion and client needed an effective protection system.

- * General view of screws after 1 year in service ,
- * The view after surface preparation ,
- * Belzona® 1812 application on both sides of helical outer surfaces ,
- * Belzona® 1321 application and completed job ,

Application of Belzona® 1321 on top of the Belzona® 1812 gave smoother finish, which prevented the damp coal sticking to the screw surfaces. Local repairs to high wear areas were carried out annually to maintain the screw protection until new plant was installed in 2012.
